# Z1325-76

SPECIFICATION SHEET

## WALL HYDRANT Less Box and Cover Exposed, Vari-Temp, Non-Freeze

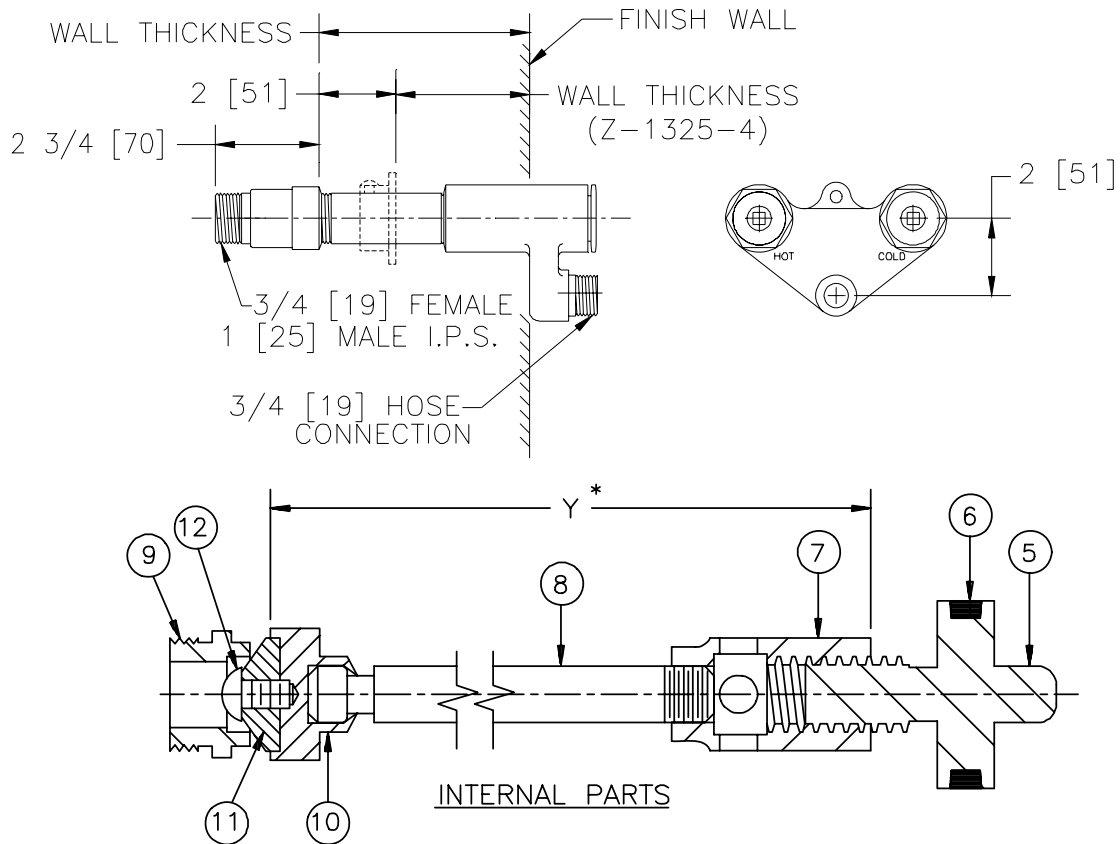
**ENGINEERING SPECIFICATION:** ZURN Z1325-76 "Vari-Temp" combination hot and cold water, non-freeze, exposed wall hydrant. Complete with bronze casing, all bronze interior parts, non-turning operating rods with free-floating compression closure valves, replacable bronze seat and seat washer, and combination 3/4 [19] female or 1 [25] male straight IP inlet. Complete with operating key.

Item	Name	Quan.
5	Operating Screw	1
6	O-Ring	1
7	Operating Coupling	1
8	Operating Rod	1
9	Removable Seat	1
10	Washer Guide	1
11	Washer (neoprene)	1
12	Screw	1

Wall Thickness Inches	Approx. Wt. Lbs. [kg]
6-8 [152-203]	27 [12]
10-12-14 [254-305-356]	31 [14]
16-18 [406-457]	35 [16]
20-22-24 [508-559-610]	39 [18]

\*WHEN ORDERING REPLACEMENT PARTS SPECIFY Y DIM.
